5 VOLT FlashFile™ MEMORY

28F004S5, 28F008S5, 28F016S5 (x8)

SPECIFICATION UPDATE

Release Date: February, 1999

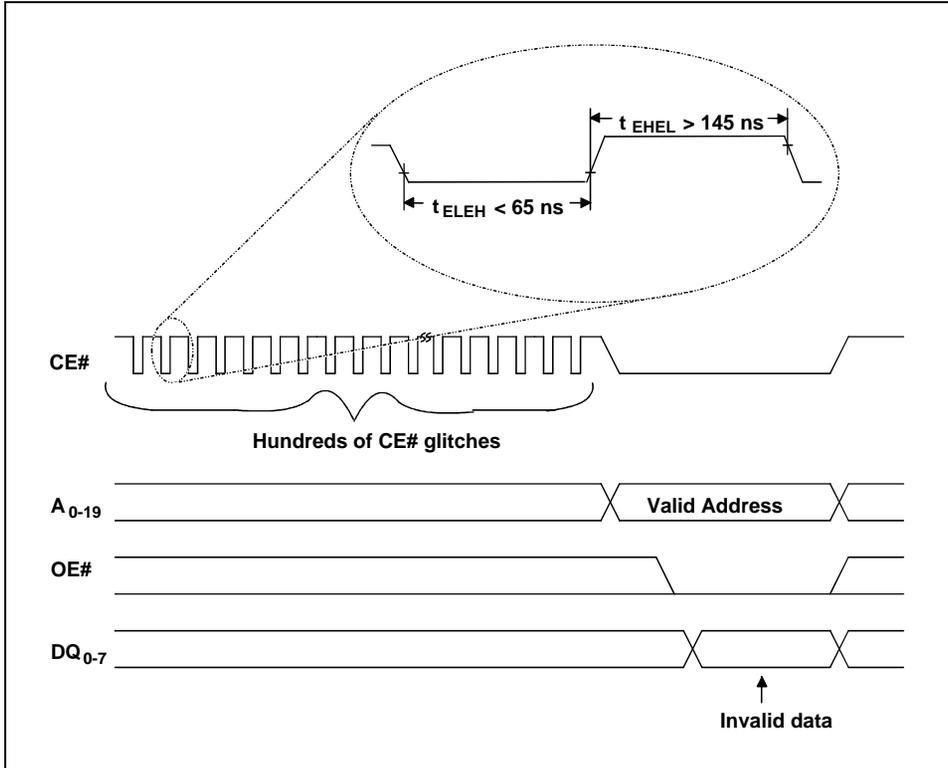
A Long Series of CE# Glitches May Induce an Invalid Read

PROBLEM: A noisy CE# control signal may cause an invalid read. This erroneous read only occurs after the device has received over one hundred consecutive short CE# glitches ($t_{EHL} < 65 \text{ ns}$) with CE#-high time (t_{EHEL}) greater than 145 ns (see the figure below, *A Long Series of CE# Glitches May Induce an Invalid Read*).

After valid data is read, the device must receive another series of CE# glitches (typically over one hundred) to induce an invalid read.

IMPLICATION: This erratum may affect read operations in systems that have a lot of noise on the flash memory's CE# input. If CE# is generated asynchronously from the upper address lines, noise on CE# can sometimes occur when upper address lines transition from one state to another. However, applications that access flash memory sequentially will have stable upper address lines and will therefore produce fewer CE# glitches. Systems that execute code from flash memory or download code from flash memory into DRAM will usually access the device sequentially; therefore, they will be less susceptible to this erratum.

1. In systems that flow unlatched addresses to CE# control logic, the decode logic may generate CE# glitches when the address bus transitions from one state to another. However, the processor's address switching frequency is usually very fast (somewhere in the order of 1/2 the processor's operating frequency) which will cause the glitch high time to be less than 145 ns. If the CE#-high time is less than 145 ns, the glitch has no effect on the component.

2. If the address bus is not pulled up or pulled down during idle bus cycles, the address bus may be left in an undetermined state. This condition may cause CE# glitches.

Add system logic to prevent CE# glitches such as latched CE# control logic or pullup/pulldown resistors to the address bus.

If the device receives over one hundred consecutive CE# glitches, issue a Byte Write command and program FFh to any location before executing a read operation. Programming FFh will not alter stored data, but it will give the component sufficient time to prepare for the read operation.

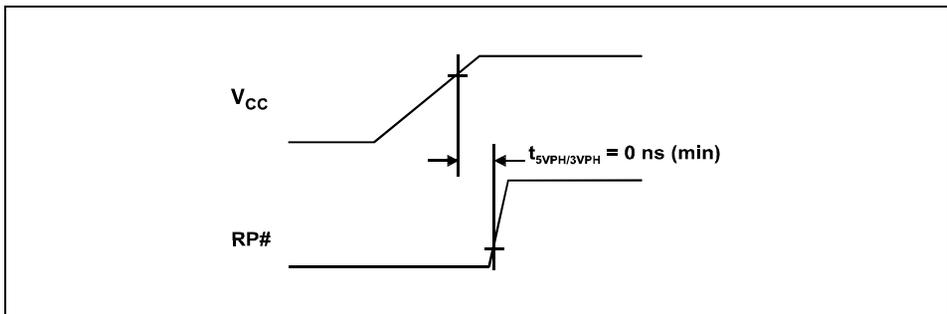
Hold RP# Active While V_{CC} Ramps

PROBLEM: RP# must be held low while V_{CC} ramps to a valid level during power transitions.

Holding RP# low during power-up blocks spurious writes initiated by system control logic which may occur as the system voltage transitions to a stable level. Intel recommends the use of RP# for CPU/memory reset synchronization, write protection, and deep power-down mode.

IMPLICATION: This erratum only affects power-up operations. Systems that tie the flash memory's RP# input to the system RESET# signal typically will not have a problem with erratum because the RESET# signal is usually held low during the power-up sequence to properly synchronize the CPU. However, systems that tie RP# directly to V_{CC} will be more exposed to this problem. So, carefully analyze RP# during the power-up condition to fully understand its behavior.

Use a simple RC delay network to hold RP# low during the power-up condition or tie the RP# input to the system RESET# signal. This workaround will eliminate your exposure to this problem and also provide your design with addition power-up security.
